HELVELY PARK DAM

CLAY COUNTY, MISSOURI

MO 10584

PHASE 1 INSPECTION REPORT NATIONAL DAM SAFETY INSPECTION

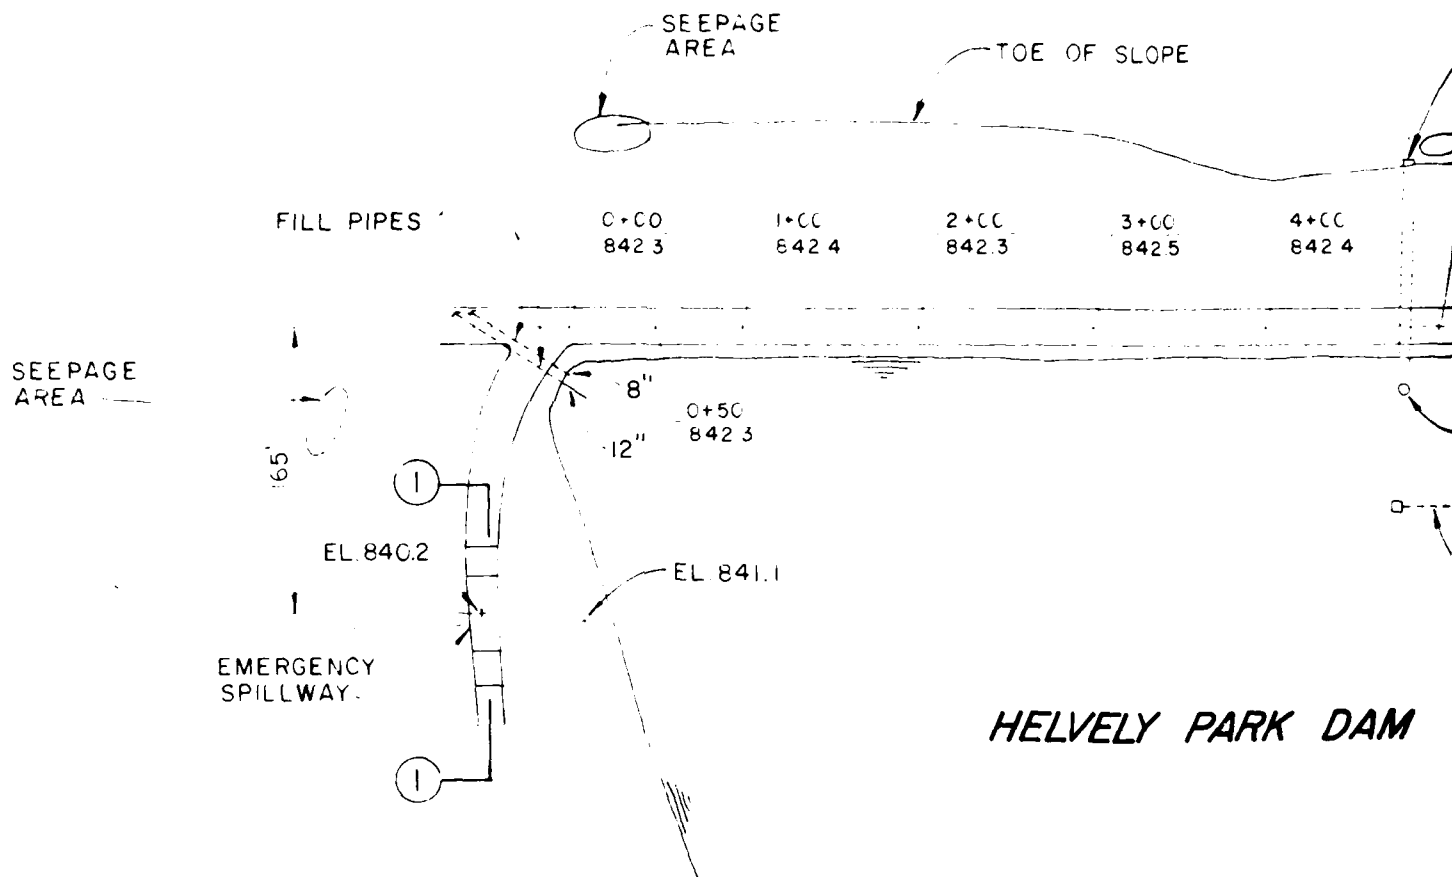
HELVELY PARK DAM
TYPICAL SECTIONS

b. Dam. The inspection team observed the following items at the dam. In general, the embankment appeared to be in good condition. One large tree (12 inches in diameter) was growing in the upstream face of the dam and several large trees (2 to 12 inches) were growing in the back slope near the center of the dam. Slope protection on the front face of the dam consisted of 2 to 6 inch crushed limestone below the waterline and grass above. Some minor erosion of the front face due to wave action was observed. The back slope of the dam was protected by a good grass cover; however, some isolated bare spots with minor erosion were observed. Clear seepage estimated at one gallon per minute was observed in the general area of a shale and limestone outcrop along the right bank of the discharge channel. Nonflowing seepage was observed in natural material in the area of the left abutment along the back slope and on the north slope of the ridge forming the left abutment, (See Plate 3). A few small animal burrows were observed in the embankment. There was no evidence of sliding, cracking, settlement, or sinkholes.

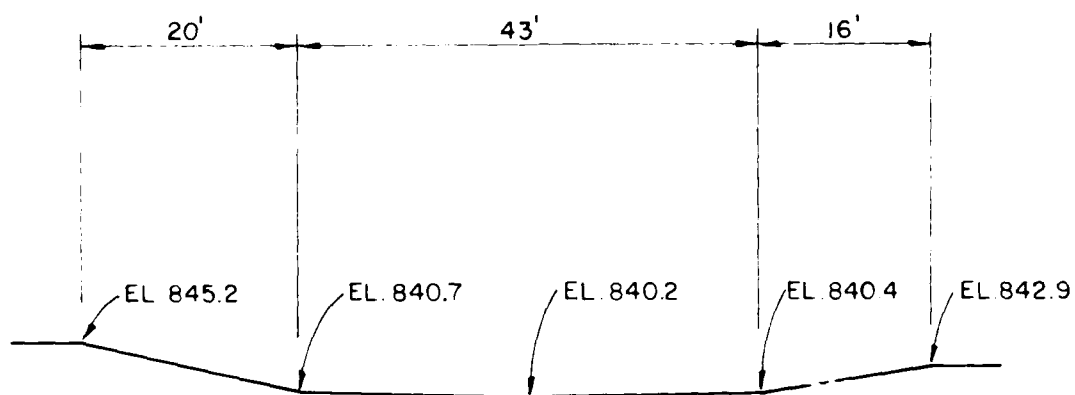
HELVELY PARK DAM
EMERGENCY SPILLWAY

Our inspection and evaluation indicates the spillway does not meet the criteria set forth in the guidelines for a dam having the above size and hazard potential. The spillway will not pass either the probable maximum flood or 50 percent of the probable maximum flood without overtopping but will pass 20 percent of the probable maximum flood, which is greater than the estimated 100-year flood. The probable maximum flood is defined as the flood discharge which may be expected from the most severe combination of critical meteorologic and hydrologic conditions that are reasonably possible in the region. Based on the size of dam and downstream hazard potential, the spillway should be capable of passing 50 percent of the probable maximum flood without overtopping the dam.

Immediate steps toward the remedy of the hydraulic inadequacy of the spillway are needed. There are no other observed deficiencies or

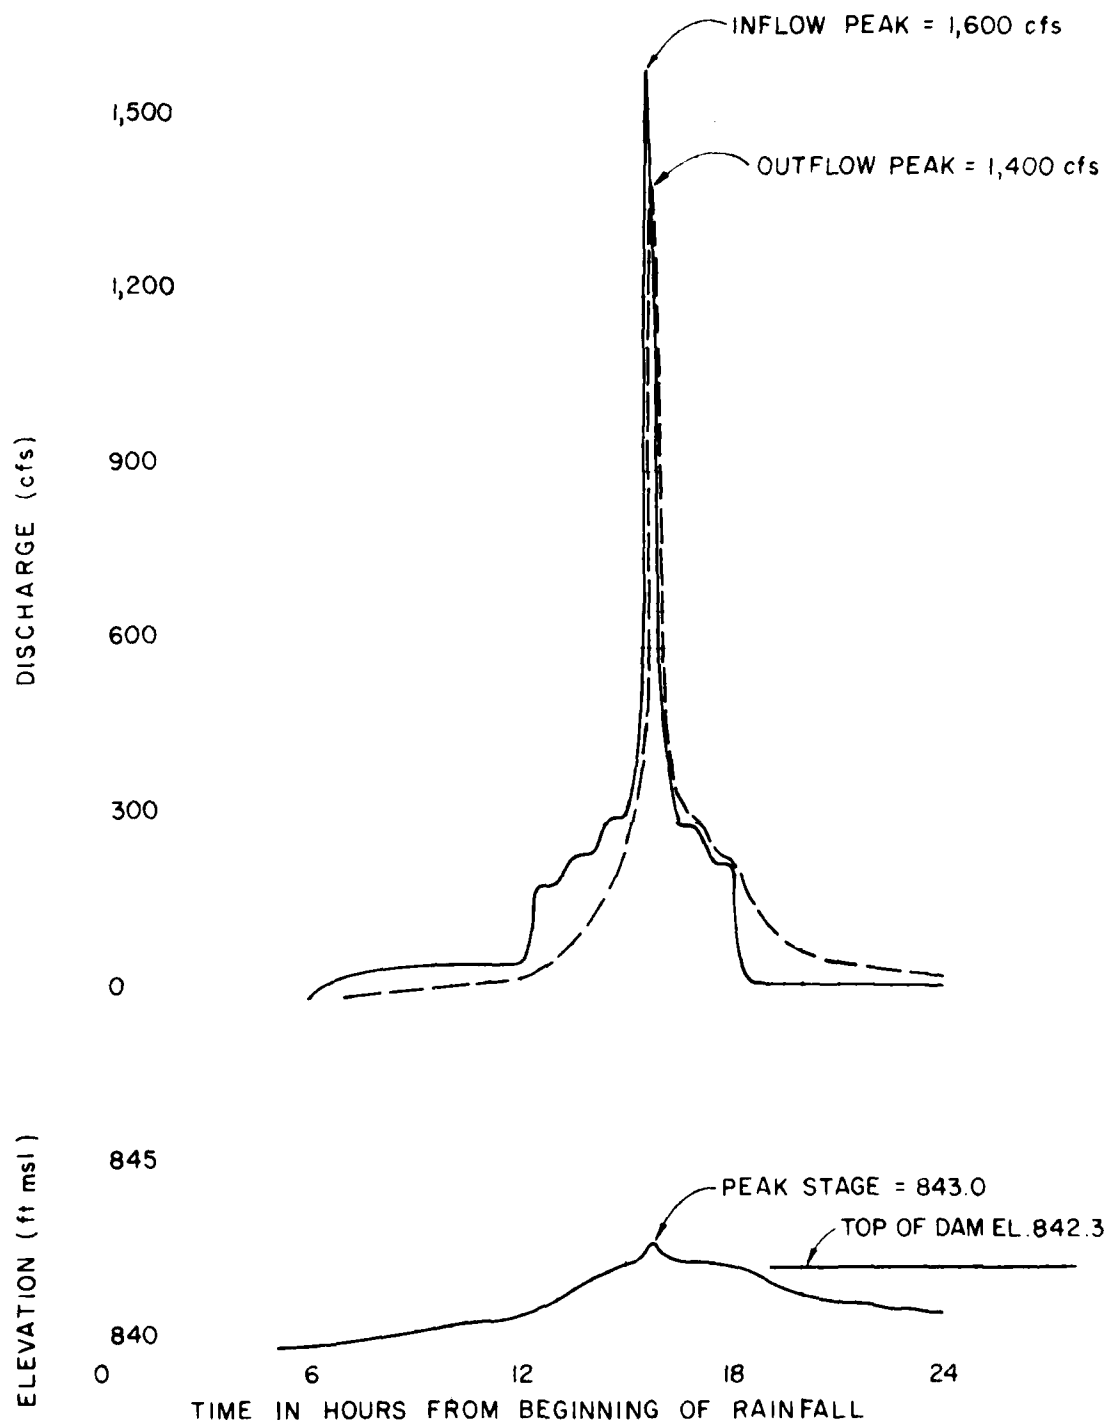
PLATE A-2

**HELVELY PARK DAM
50% PROBABLE MAXIMUM FLOOD
HYDROGRAPHS AND
STAGE - TIME CURVE**
